**CULTURAL RESOURCE INVESTIGATION AND INVENTORY
OF
INTACT BUILDINGS AND STRUCTURES
AT THE
WILCOX OIL COMPANY SUPERFUND SITE
CREEK COUNTY,
BRISTOW, OKLAHOMA**

**U.S. ARMY CORPS OF ENGINEERS
REGIONAL PLANNING & ENVIRONMENTAL CENTER**

March 28, 2016

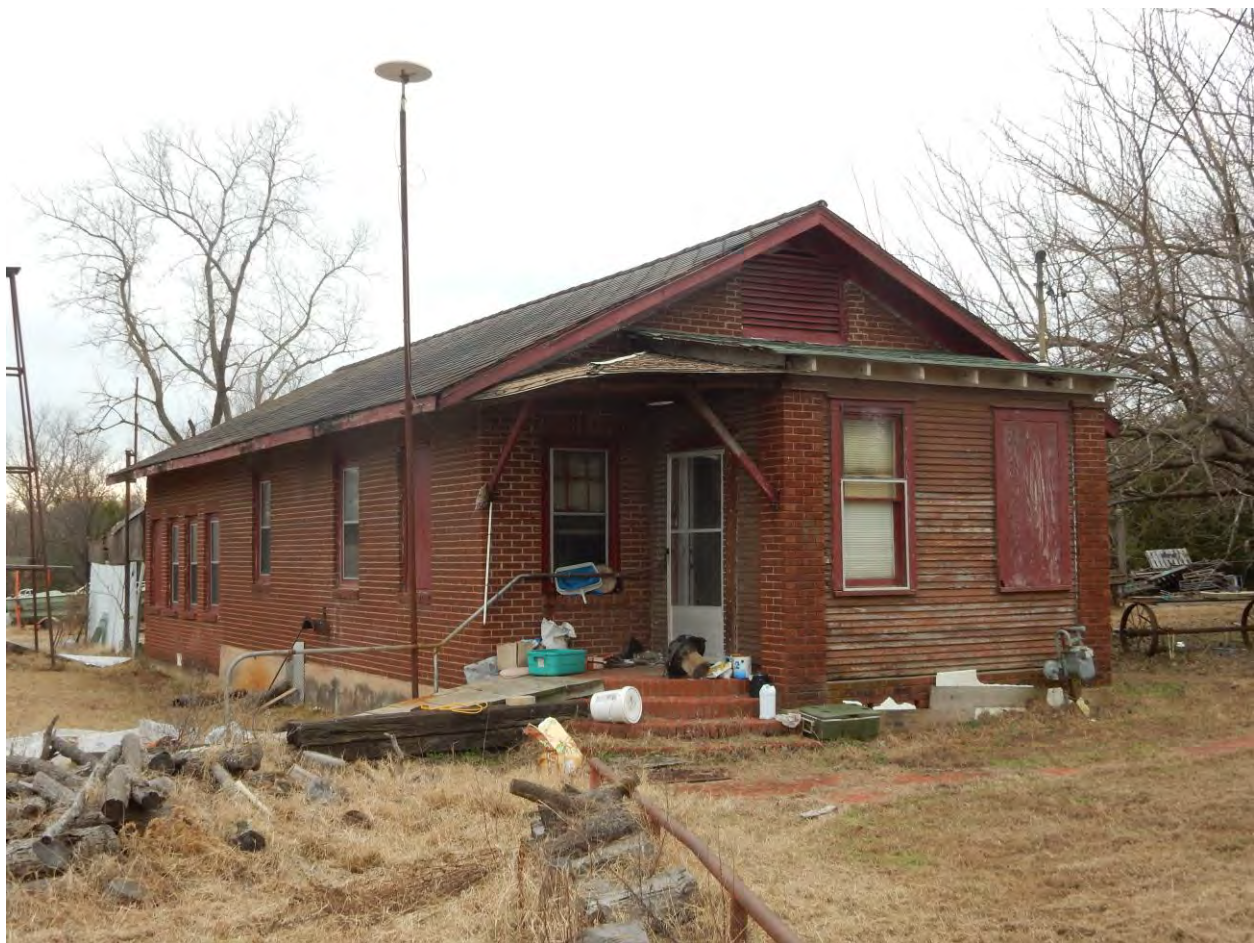
50. CONDITION OF RESOURCE: POOR (BADLY IN NEED OF MAINTENANCE)

51. DESCRIPTION OF RESOURCE: THIS SIMPLE STRUCTURE WAS ORIGINALLY THE MAIN OFFICE OF THE WILCOX OIL COMPANY AND IS TODAY A DWELLING. IT HAS NUMEROUS ADDITIONS AND NO LONGER CONVEYS ITS SIGNIFICANCE.

52. COMMENTS: RESOURCE HAS LOST INTEGRITY THROUGH INFILL OF FRONT PORCH, NUMEROUS ADDITIONS, REPLACING ORIGIONAL WOOD CLADDING WITH MASONRY. REMOVAL AND REPLACEMENT OF WINDOWS

PHOTOGRAPH OF THE FORMER WILCOX OIL COMPANY MAIN OFFICE. THE ORIGINAL WOOD STRUCTURE HAS HAD A BRICK VENEER APPLIED, THE FRONT PORCH HAS BEEN FILLED IN AND A MAJOR ADDITION WAS ADDED TO THE REAR AT AN UNKNOWN DATE. THE STRUCTURE HAS LOST INTEGRITY.

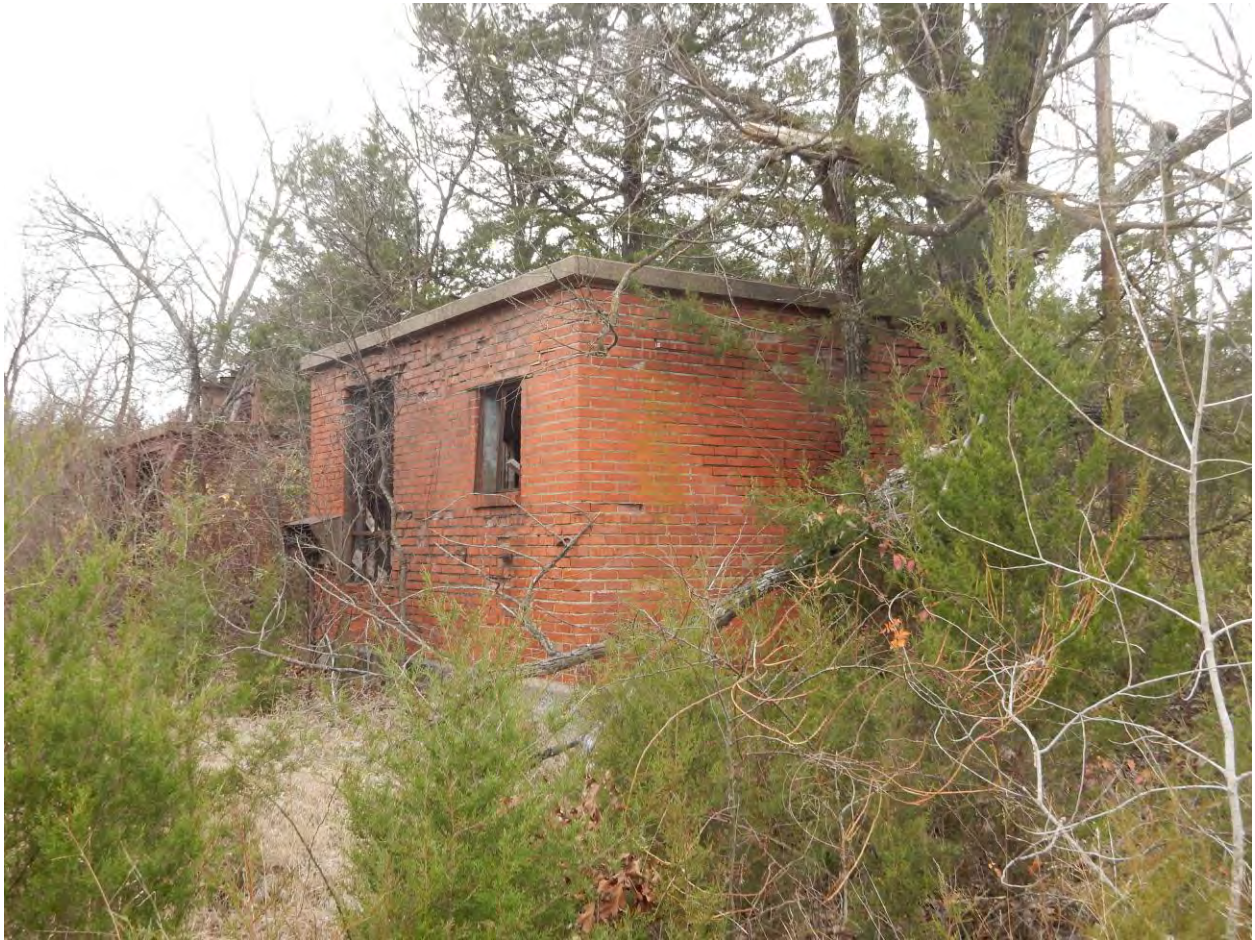
50. CONDITION OF RESOURCE: POOR (BADLY IN NEED OF MAINTENANCE)

A MASONRY PROCESS BUILDING OF THE WILCOX OIL REFINERY. ALMOST CONSIDERED A RUIN.

BUILDING HAS BEEN ABANDONED SINCE 1963.

PHOTOGRAPH OF THE FORMER WILCOX OIL COMPANY PROCESS BUILDING 1.

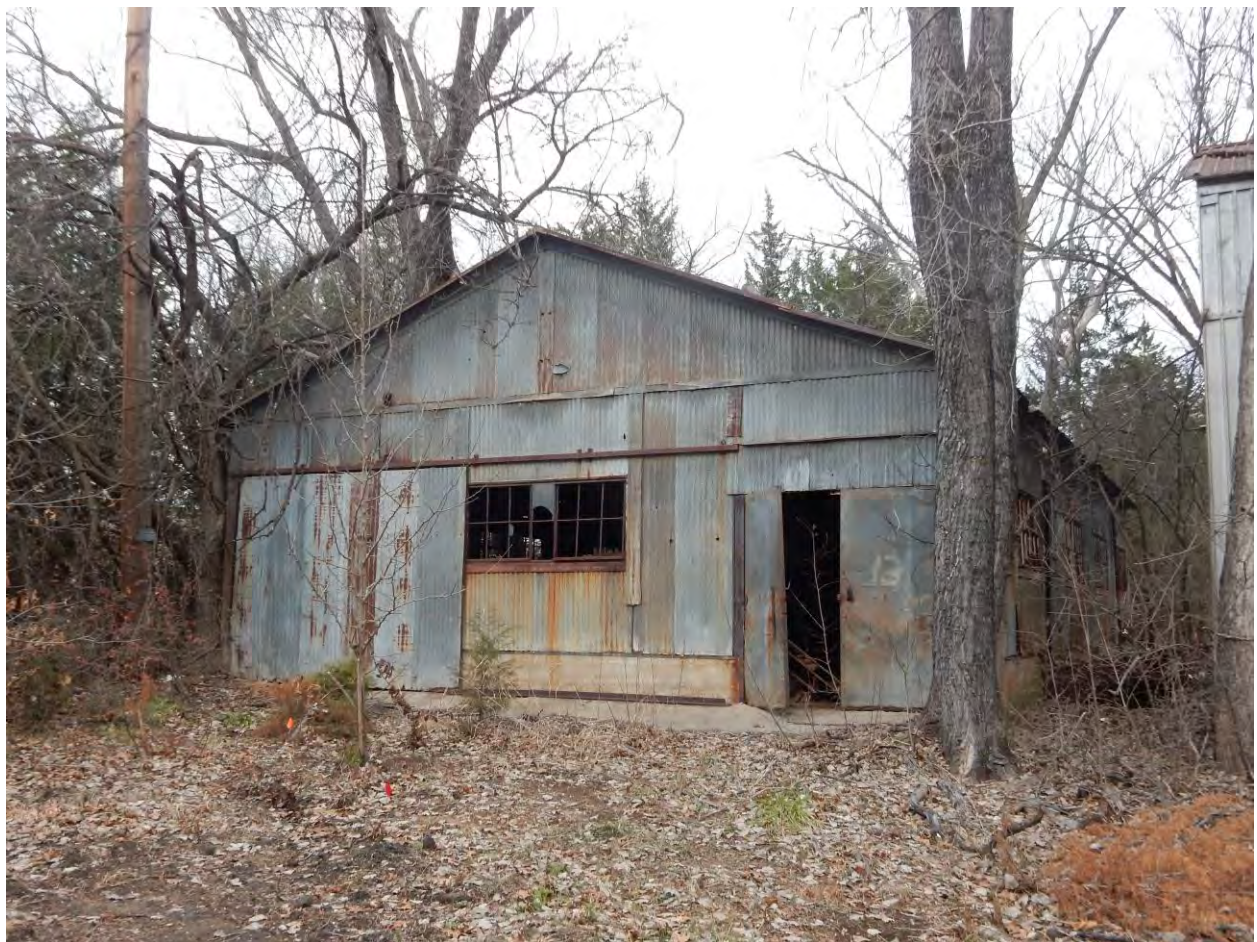
50. CONDITION OF RESOURCE: POOR (BADLY IN NEED OF MAINTENANCE)

A STEEL FRAMED PROCESS BUILDING OF THE WILCOX OIL REFINERY

BUILDING HAS BEEN ABANDONED SINCE 1963.

PHOTOGRAPH OF THE FORMER WILCOX OIL COMPANY PROCESS BUILDING 2.

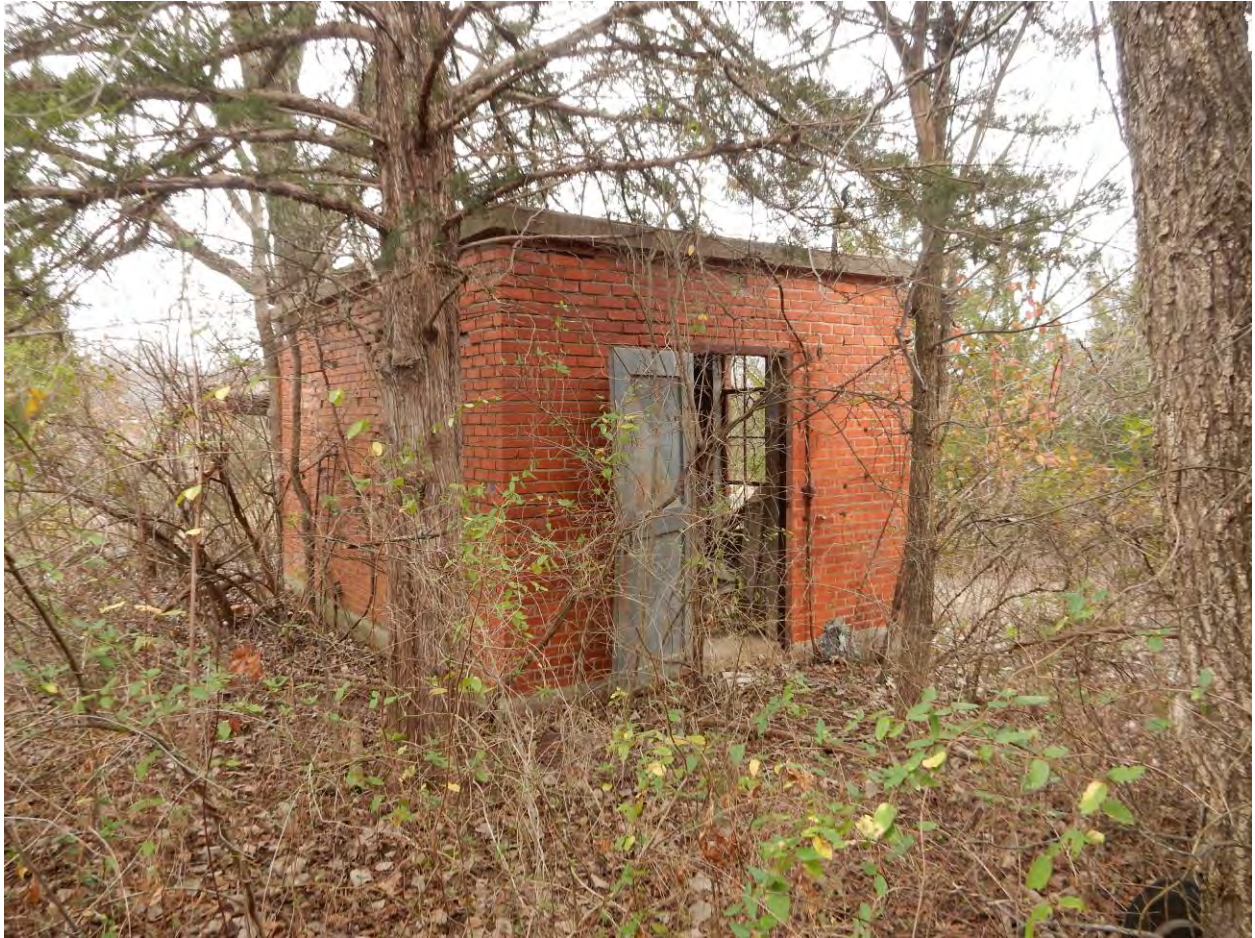
50. CONDITION OF RESOURCE: POOR (BADLY IN NEED OF MAINTENANCE)

A MASONRY PROCESS BUILDING OF THE WILCOX OIL REFINERY

BUILDING HAS BEEN ABANDONED SINCE 1963.

PHOTOGRAPH OF THE FORMER WILCOX OIL COMPANY PROCESS BUILDING 3.

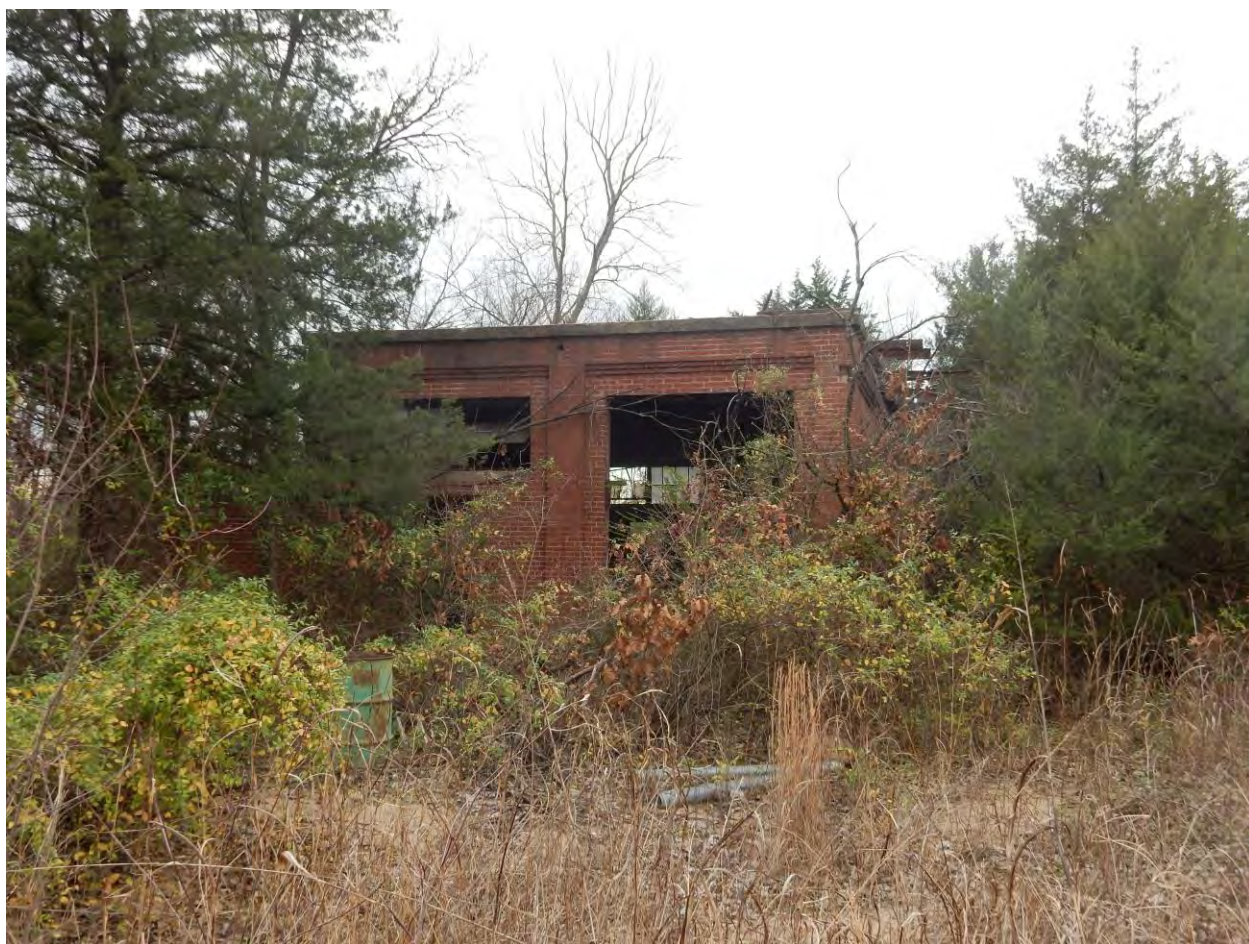
50. CONDITION OF RESOURCE: POOR (BADLY IN NEED OF MAINTENANCE)

51. DESCRIPTION OF RESOURCE: A MASONRY PROCESS BUILDING OF THE WILCOX OIL REFINERY

52. COMMENTS: BUILDING HAS BEEN ABANDONED SINCE 1963.

PHOTOGRAPH OF THE FORMER WILCOX OIL COMPANY PROCESS BUILDING 4.

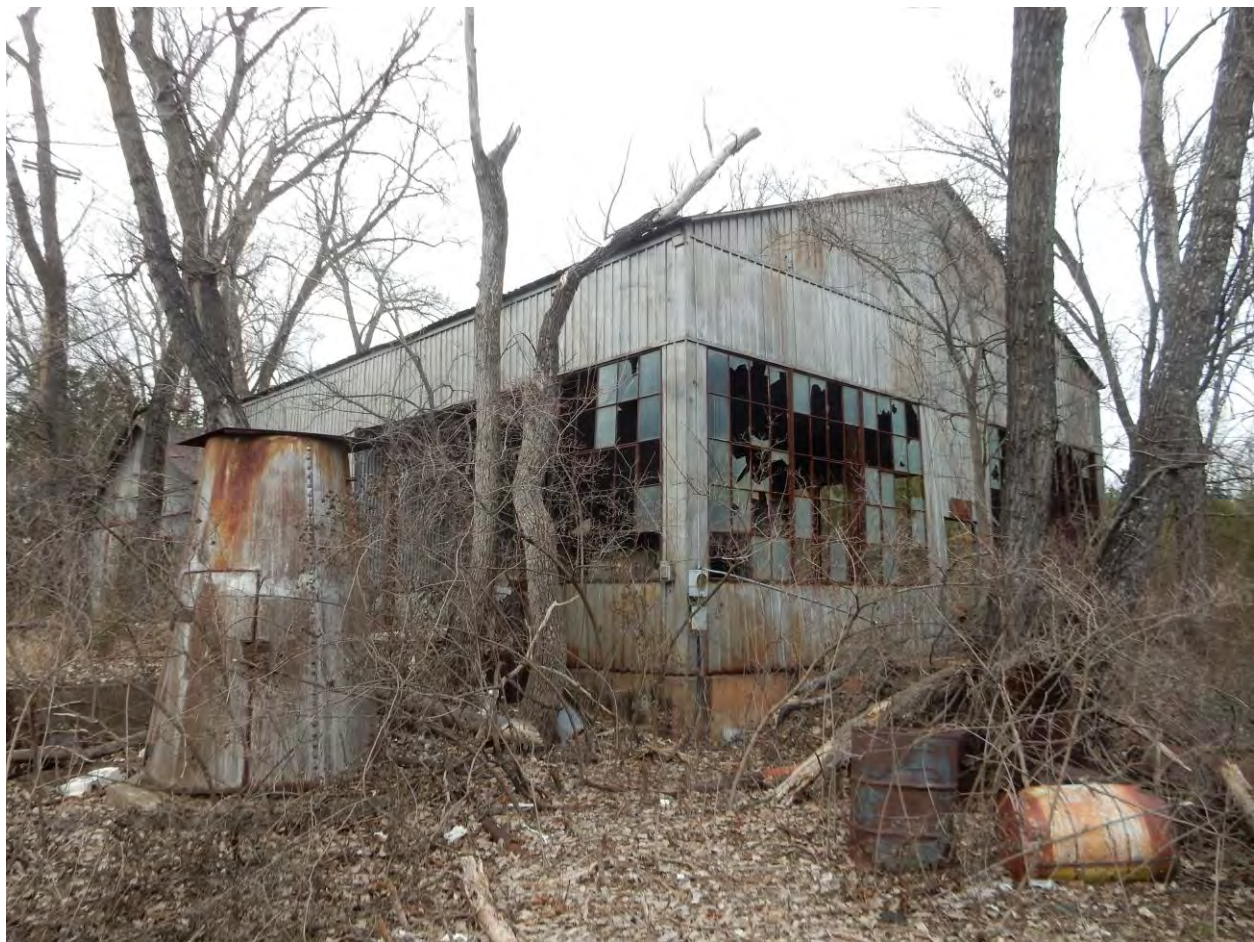
50. CONDITION OF RESOURCE: POOR (BADLY IN NEED OF MAINTENANCE)

PHOTOGRAPH OF THE FORMER WILCOX OIL COMPANY PROCESS BUILDING 5.

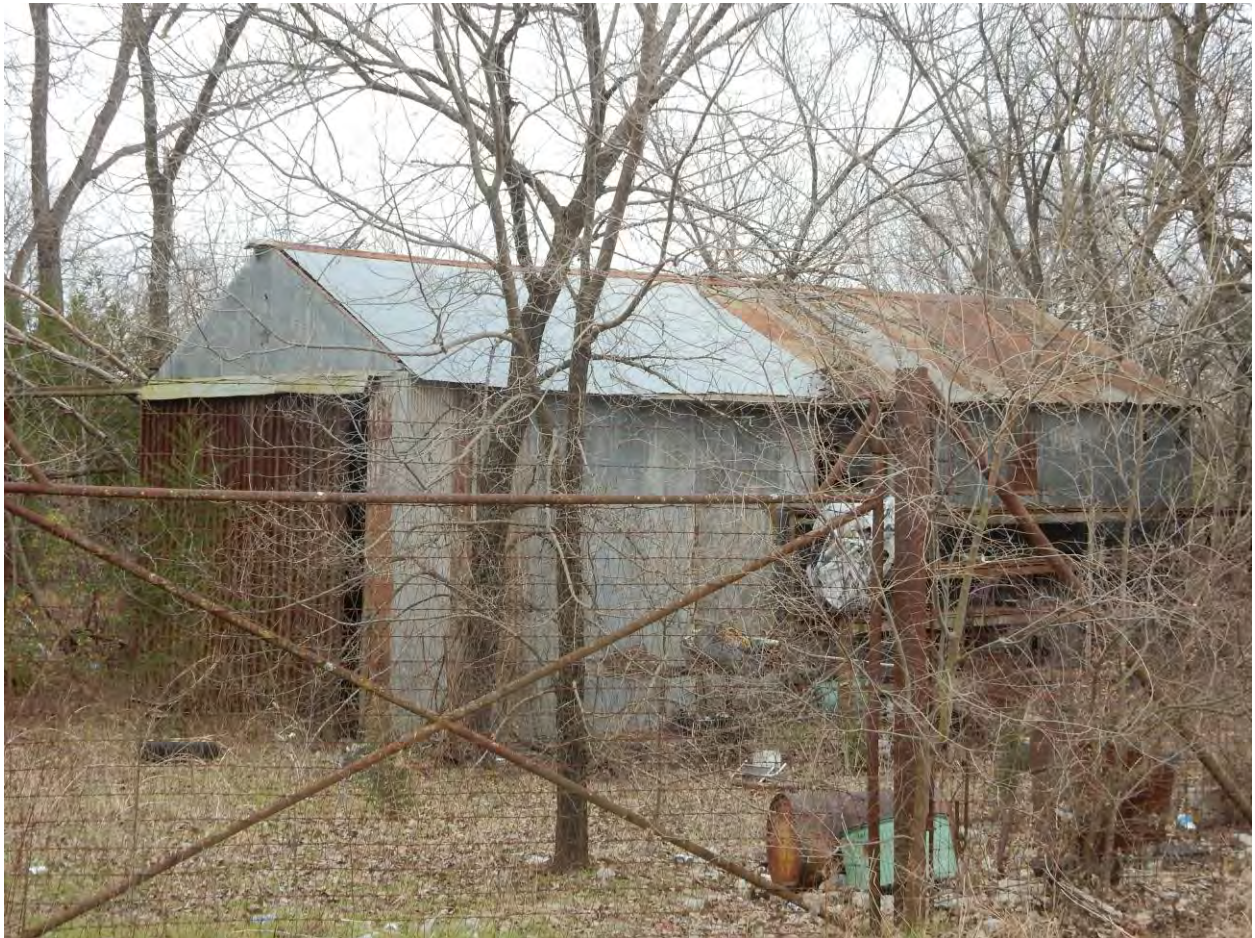
50. CONDITION OF RESOURCE: POOR (BADLY IN NEED OF MAINTENANCE)

PHOTOGRAPH OF THE FORMER WILCOX OIL COMPANY SHED.

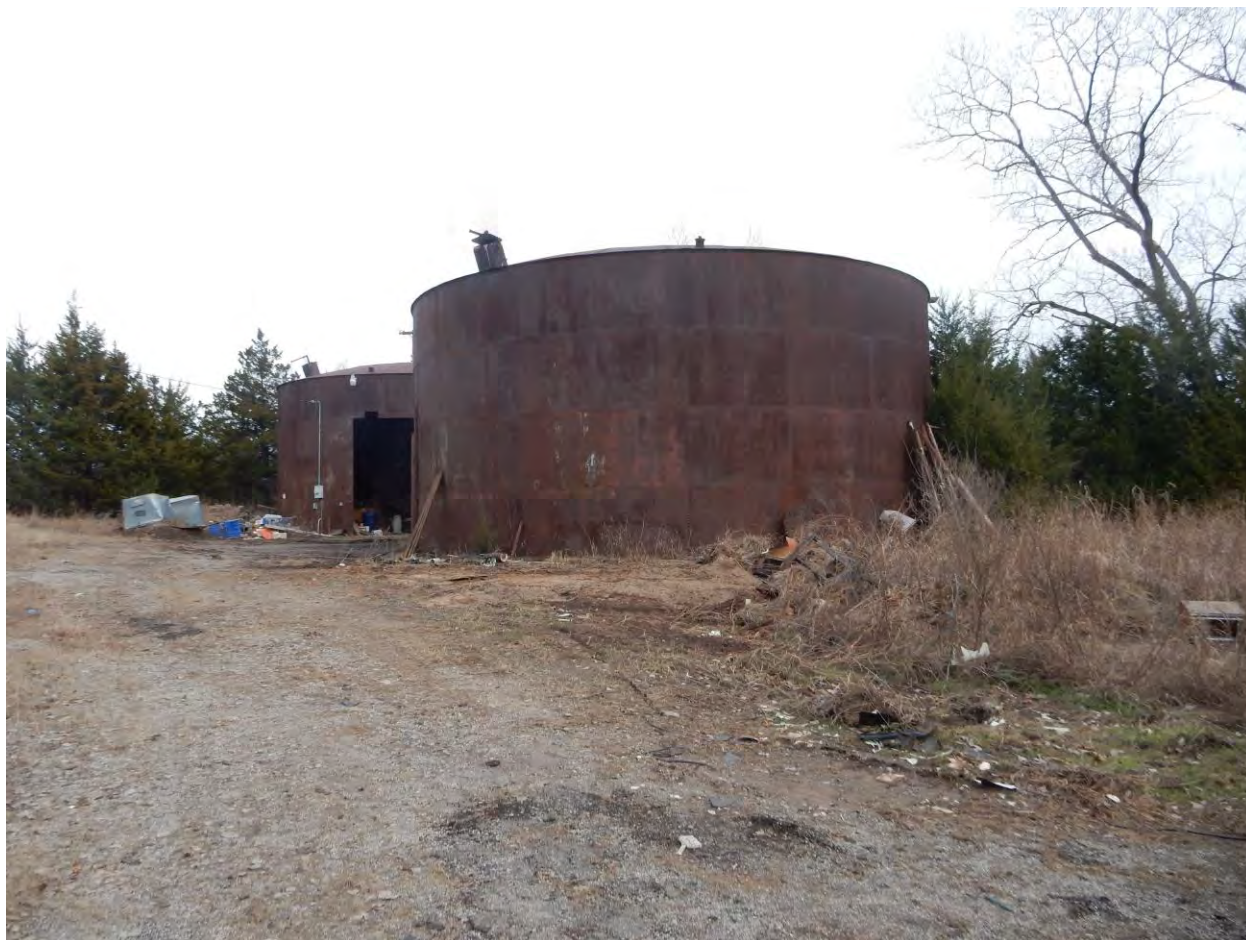
50. CONDITION OF RESOURCE: RUINS (MOST OR ALL OF RESOURCE IS DESTROYED)

PHOTOGRAPH OF TANK 1 (FOREGROUND) OF THE FORMER WILCOX OIL REFINERY, BRISTOW OKLAHOMA. NONE OF THE FIVE REMAINING TANKS ARE IN A USABLE CONDITION.

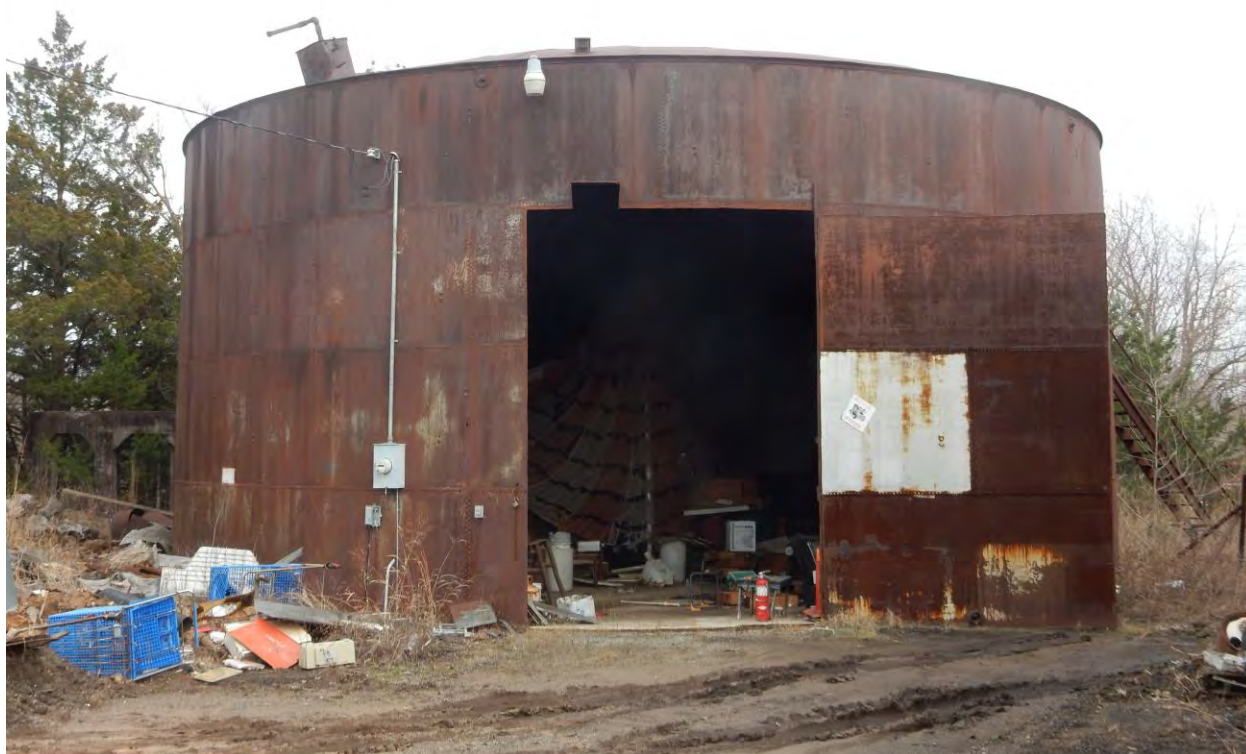
50. CONDITION OF RESOURCE: RUINS (MOST OR ALL OF RESOURCE IS DESTROYED)

PHOTOGRAPH OF TANK 2 OF THE FORMER WILCOX OIL REFINERY, BRISTOW OKLAHOMA. NONE OF THE FIVE REMAINING TANKS ARE IN A USABLE CONDITION.

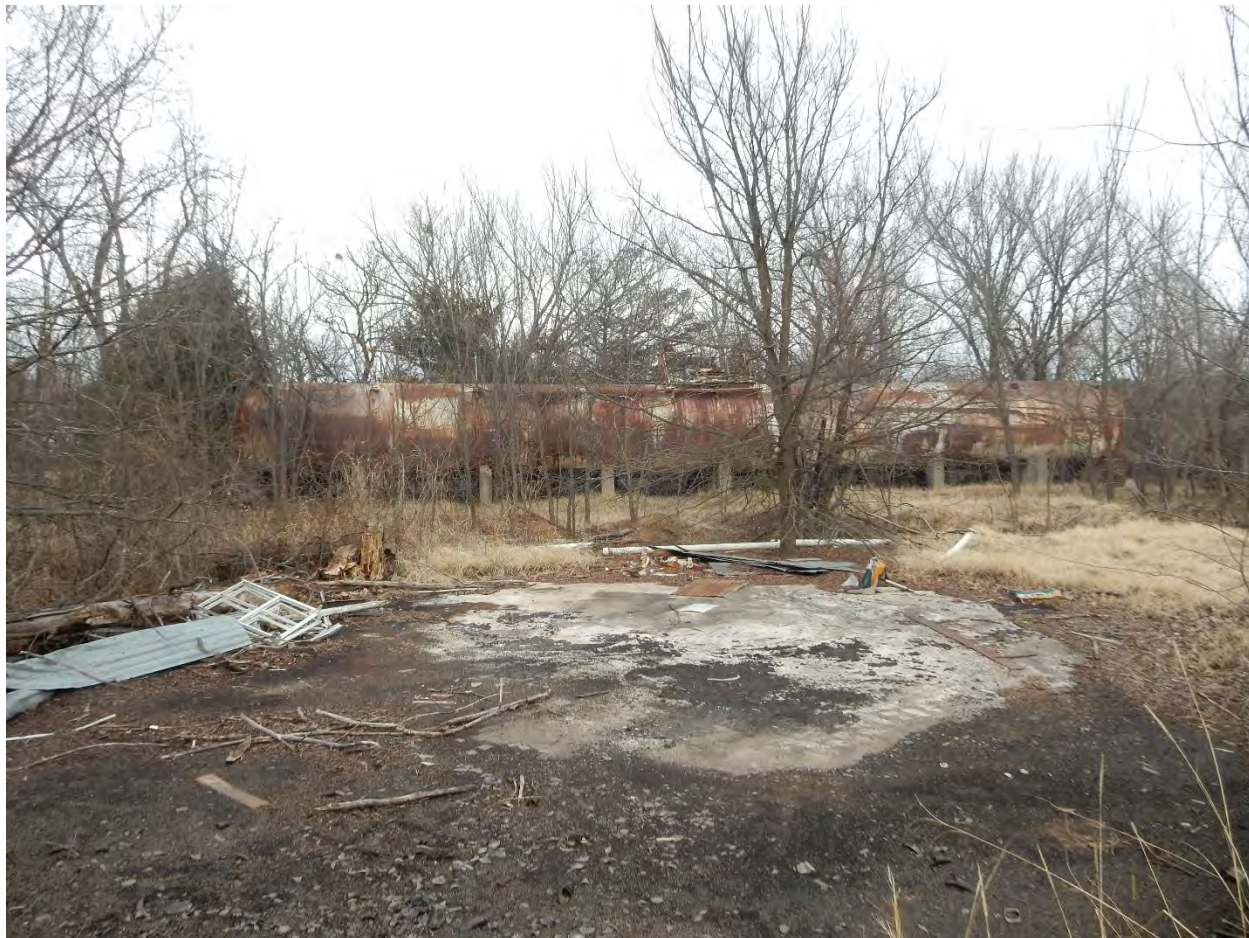
50. CONDITION OF RESOURCE: RUINS (MOST OR ALL OF RESOURCE IS DESTROYED)

PHOTOGRAPH OF TANK 3 OF THE FORMER WILCOX OIL REFINERY, BRISTOW OKLAHOMA. NONE OF THE FIVE REMAINING TANKS ARE IN A USABLE CONDITION.

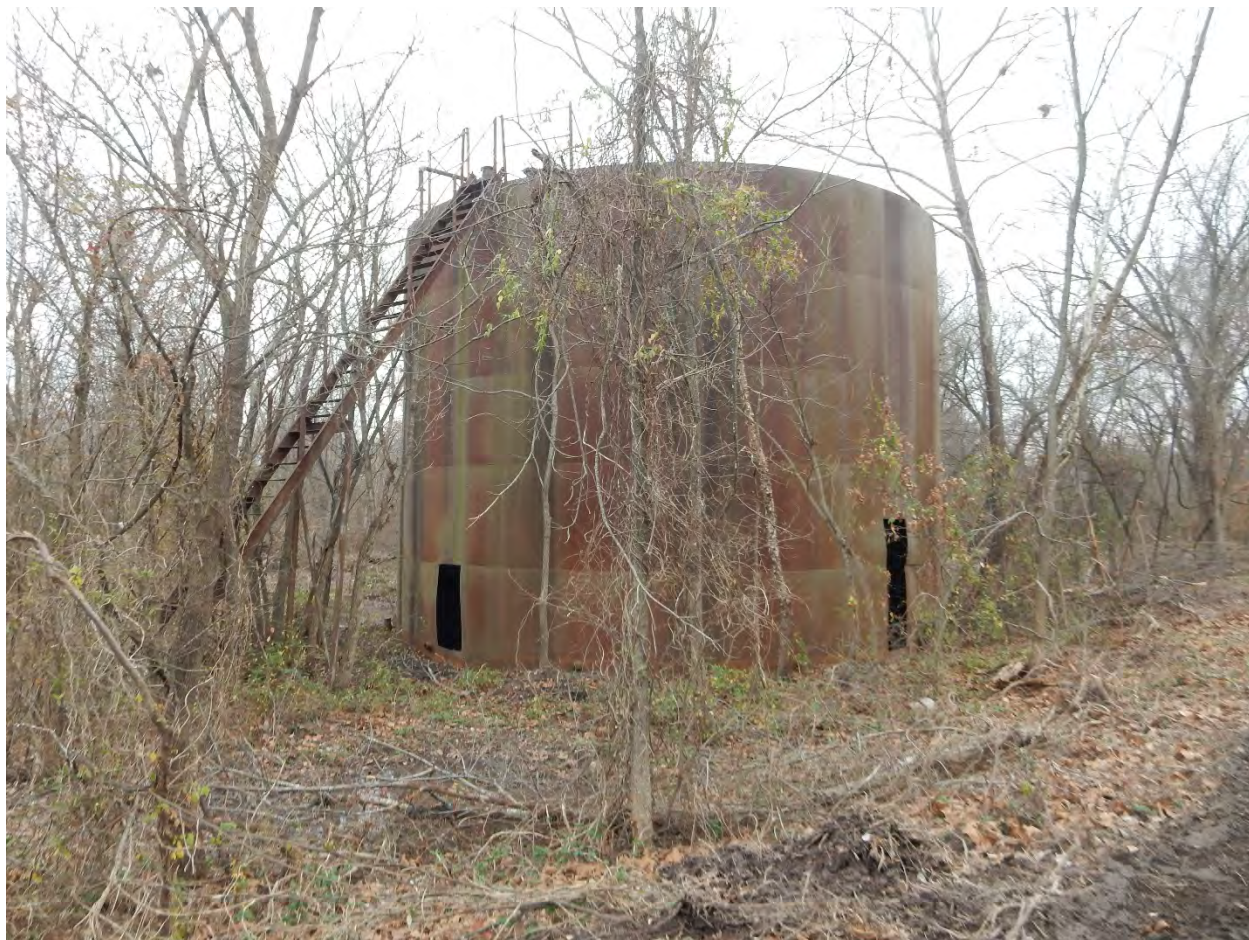
50. CONDITION OF RESOURCE: RUINS (MOST OR ALL OF RESOURCE IS DESTROYED)

PHOTOGRAPH OF TANK 4 OF THE FORMER WILCOX OIL REFINERY, BRISTOW OKLAHOMA. NONE OF THE FIVE REMAINING TANKS ARE IN A USABLE CONDITION.

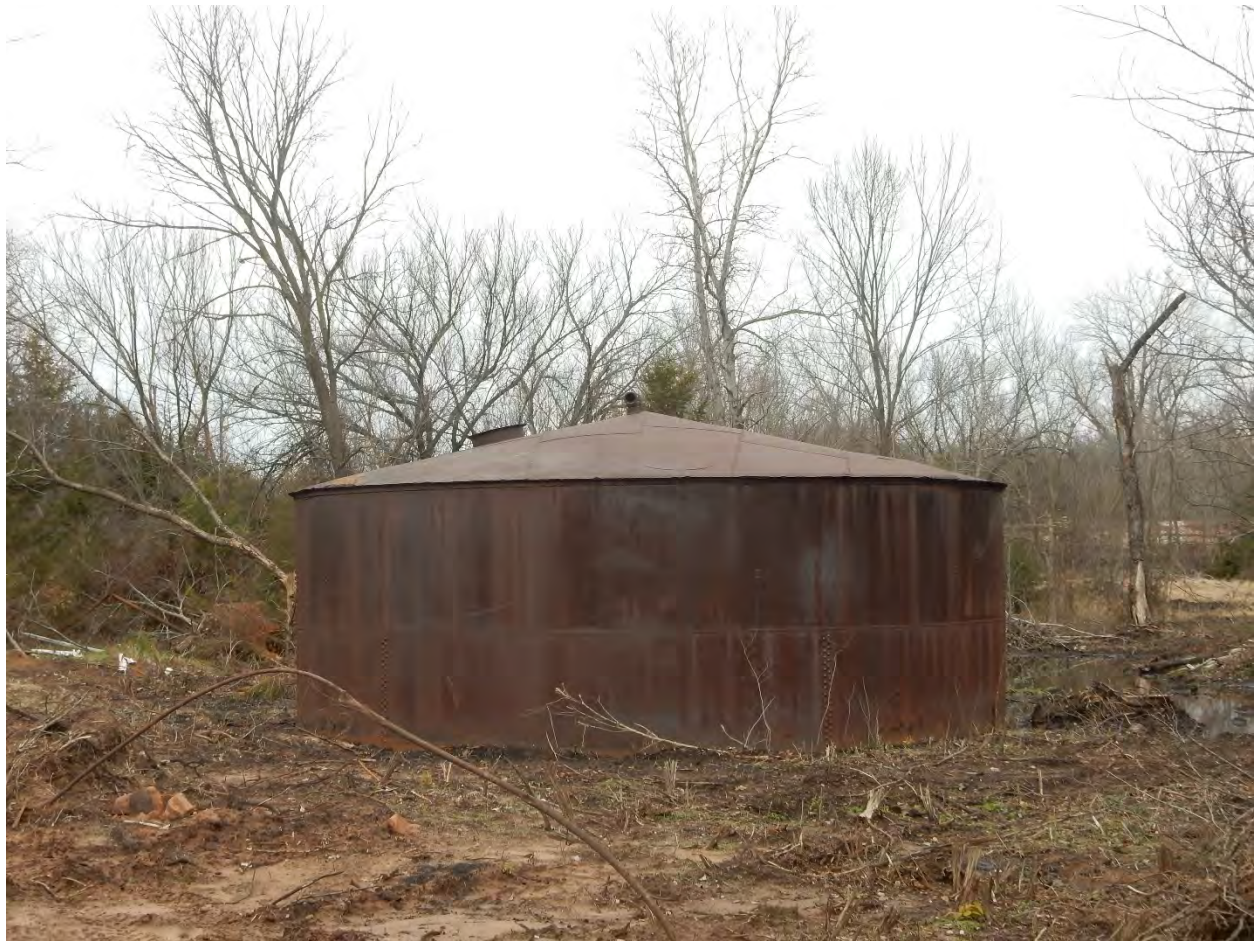
50. CONDITION OF RESOURCE: RUINS (MOST OR ALL OF RESOURCE IS DESTROYED)

PHOTOGRAPH OF TANK 5 OF THE FORMER WILCOX OIL REFINERY, BRISTOW OKLAHOMA. NONE OF THE FIVE REMAINING TANKS ARE IN A USABLE CONDITION.

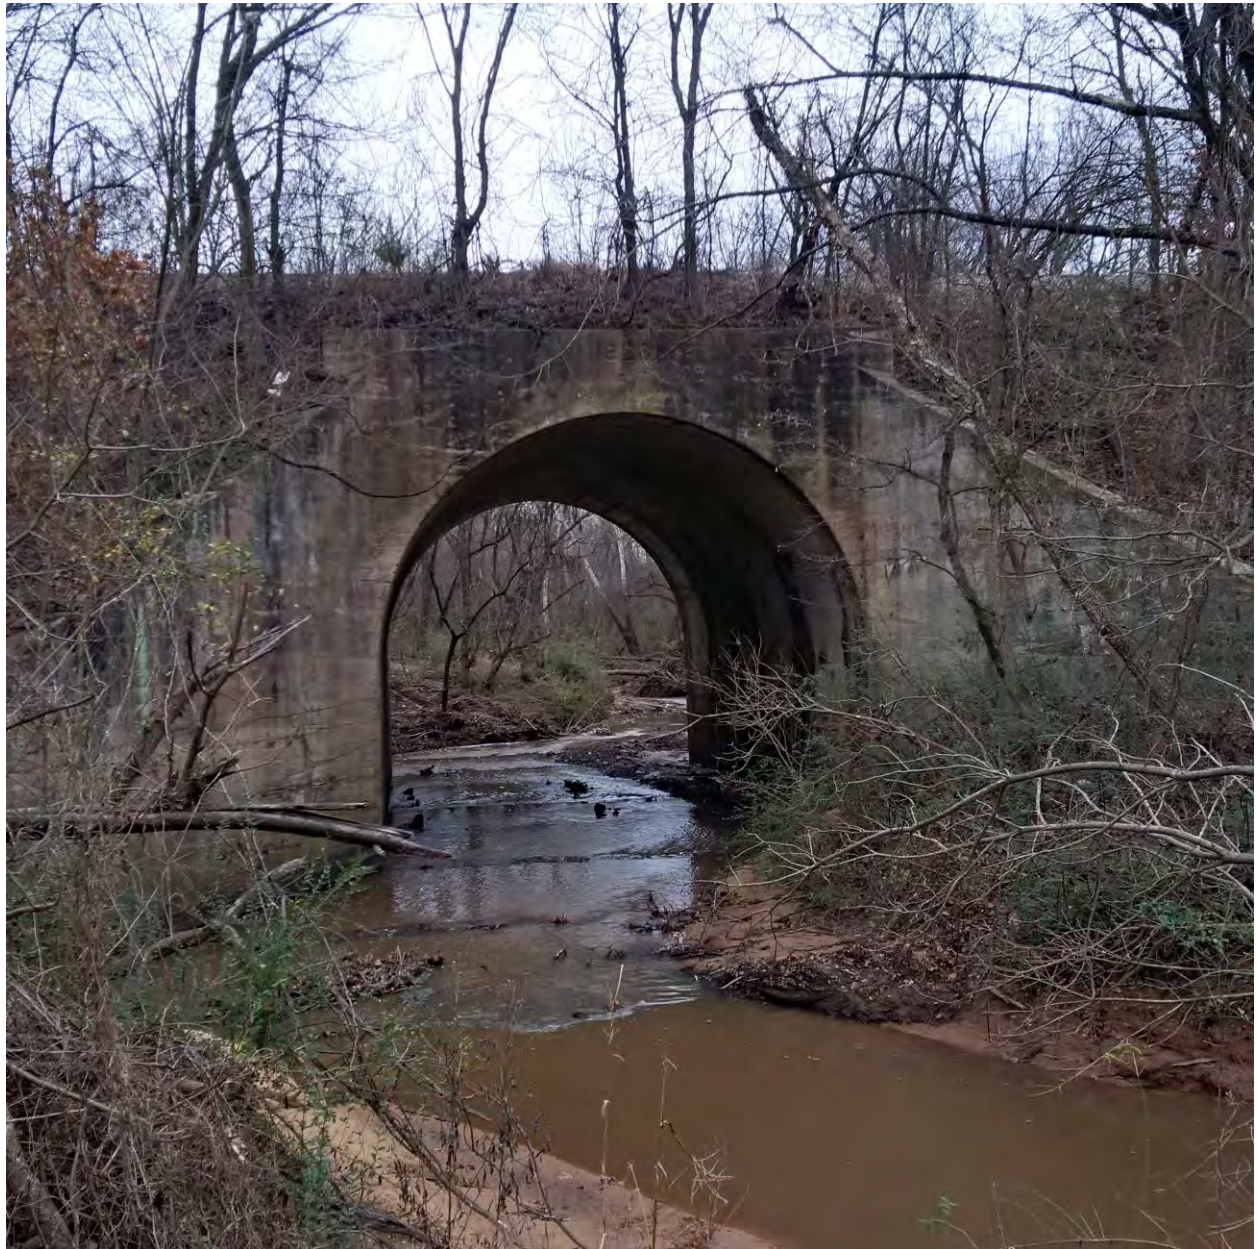
The Sand Creek Railroad culvert was constructed in 1923 as evidenced by the inscription on the top of the headwall on each side of the structure. This simple reinforced concrete structure consists of a barrel-vaulted reinforced concrete arch (approximately 16 feet in diameter) with concrete headwalls on each side of the railroad grade that is elevated approximately 25 feet above Sand Creek which flows in an east-west direction. Flared reinforced-concrete wing walls extend from each side of the headwall and decrease in height toward the creek bed.

The Sand Creek concrete railroad culvert is a true representative example of early twentieth century concrete culvert construction. It represents the limits of culvert construction in size and is a transitional example of the application of the type where a bridge could have as easily been used. The Sand Creek culvert is significant under Criterion C at a state level as an example of early twentieth century reinforced concrete culvert railroad construction in Oklahoma and retains a very high degree of integrity of location, setting, design, materials, workmanship, feeling and association.

50. CONDITION OF RESOURCE: GOOD (VERY WELL MAINTAINED)

PHOTOGRAPH OF THE SAND CREEK RAILROAD CULVERT.
